# TRUCKEE RIVER PATH INVENTORY STUDY REPORT

REGIONAL  
TRANSPORTATION  
COMMISSION

This report provides an inventory of the Truckee River Path, a 11.2 mile corridor of paved shared-use path, for non-motorized users, located along the Truckee River from Riverhaven Drive in Reno to Larkin Circle in Sparks. The inventory was conducted in July and August of 2024 and includes both the physical infrastructure of the path and observations of the surrounding environment that may impact user experience.

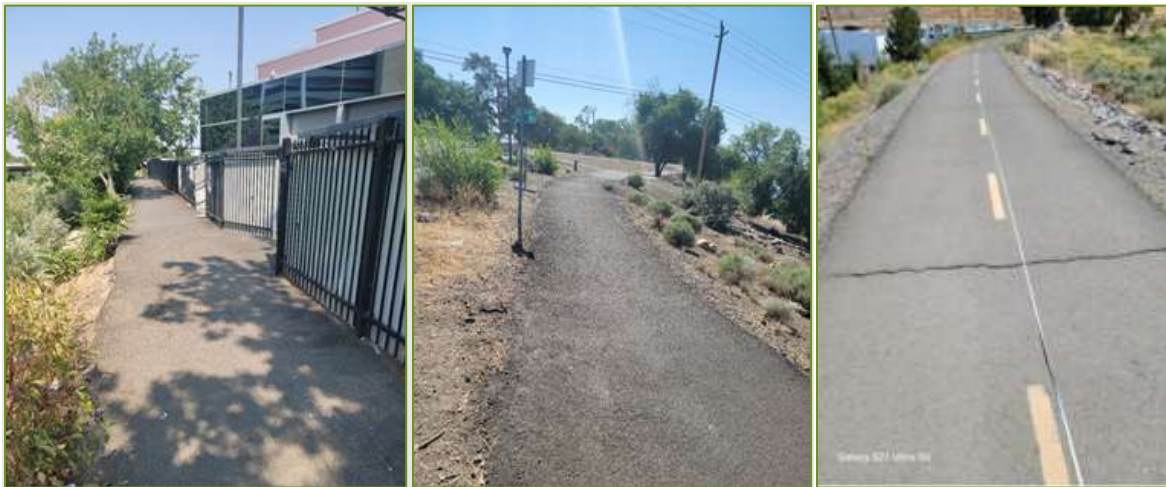
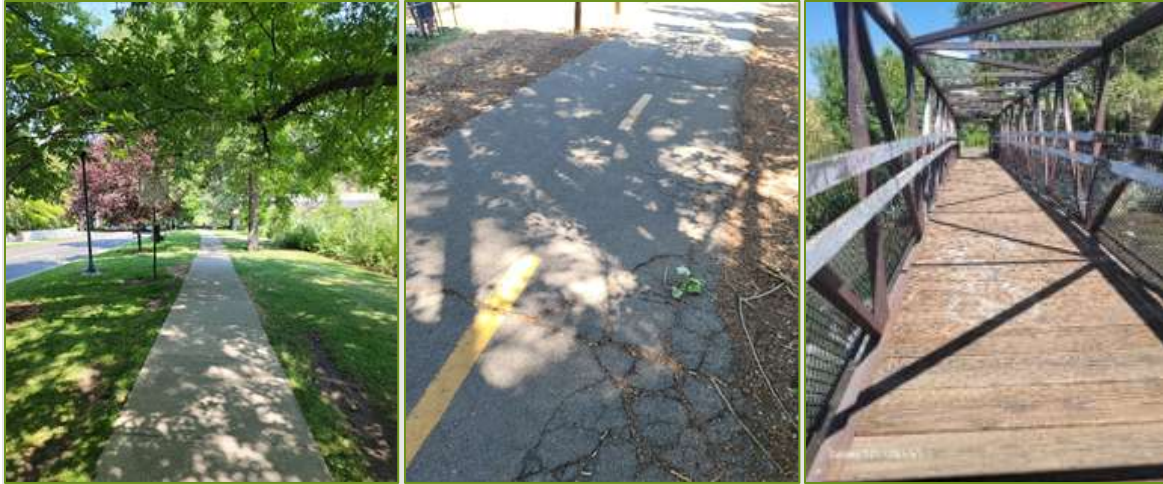
Examples of photos taken as part of the surface condition assessments are shown as Figure 4. About 8.2 miles (73%) of the path surface was found to be in good condition (Figure 6). Asphalt comprises a significant portion of the path, with around 6.1 miles (54.5%) in good condition and 2.73 miles (24.4%) in poor condition, while concrete sections account for another 2.0 miles (18.1%) in good condition and 0.04 miles (0.3%) in poor condition.

*Figure 3-Path Surface Material and Condition*

Figure 4 (Continued)-Path Surface Material and Condition

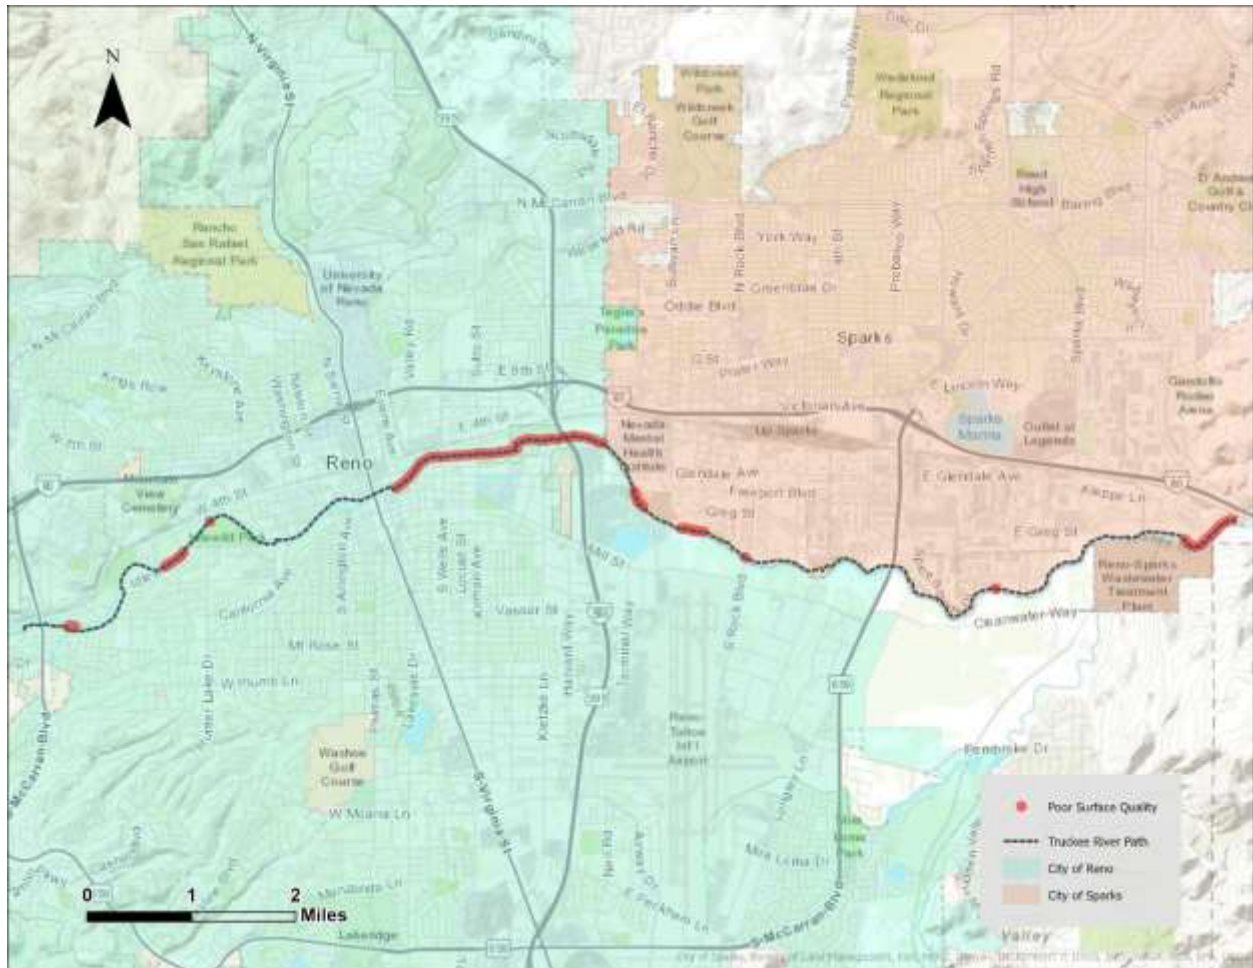
The remaining 0.06 miles (0.5%) consist of bridges, which are constructed with a variety of wood products. All wooden bridge surfaces were found to be in good condition. About 0.25 miles (2.2%) of the path was not assessed due to accessibility or safety reasons. These segments are classified as “Other”. Path locations with the most concentrated areas of poor surface condition were between Lake Street and Galletti Way, where sections of asphalt displayed wear, including horizontal and vertical cracking, crumbling edges, and uneven surfaces (Figure 6).

Figure 6-Areas of Poor Surface Condition

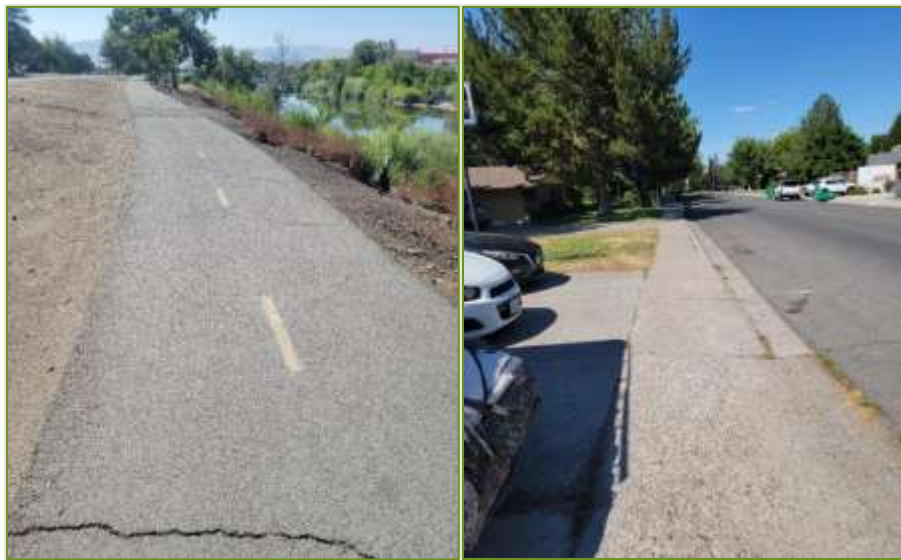
Most of the path was found to measure between 7 feet and 14 feet (Figure 10). Locations wider than 10 feet were generally within parks and adjacent open spaces. Path locations less than 10 feet wide, were generally those in residential areas, including along Idlewild Drive. In the locations where the path was narrower, widths were between 3 and 5 feet.

Examples of path locations less than 10 feet wide include neighborhood areas with sidewalk infrastructure connecting to the path, locations on bridges or overpasses, and some pedestrian-focused sections such as along Riverside Drive, where bicycle users are transitioned to the Bicycle Boulevard corridor (Figure 11).

Figure 10-Path Width Examples (Meets Recommendation / Does Not Meet Recommendation)

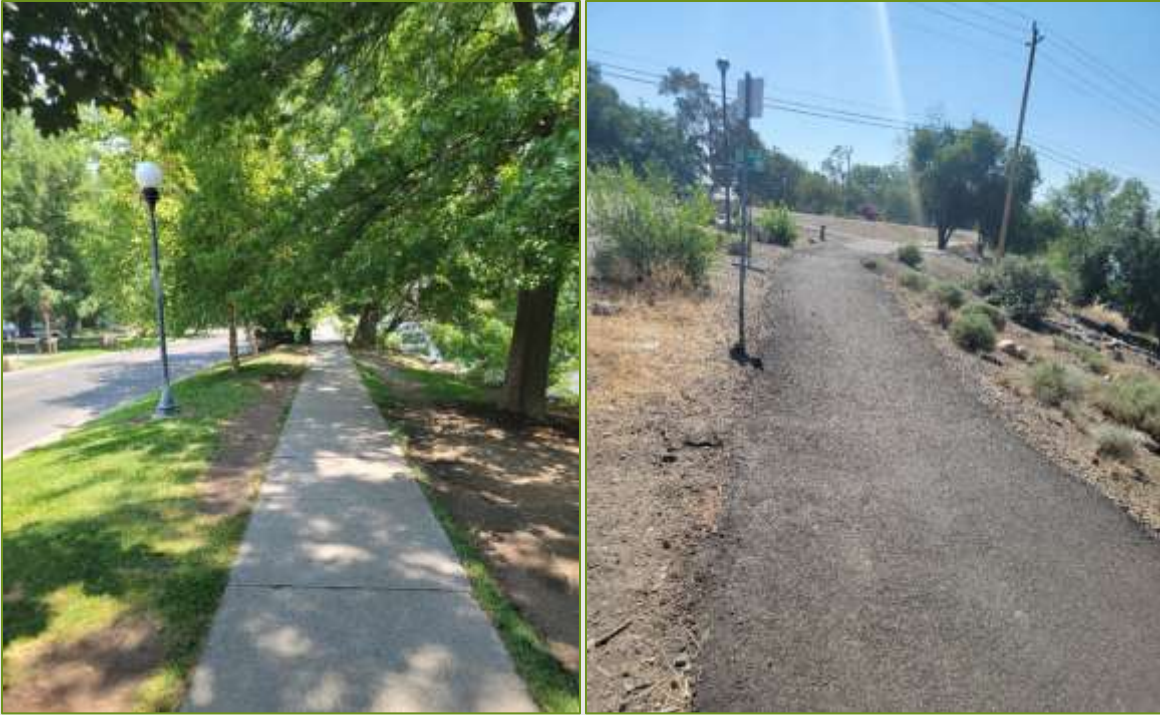
The inventory found approximately 35 locations along the path where the longitudinal slope measurements exceeded 5% and approximately 241 sites that had cross slope measurements exceeding 2%. These sites are dispersed throughout the path, with a combination of areas exhibiting both good and poor surface quality, as well as varying surface material. Figure 15 shows examples of locations with different longitudinal slopes and surface material.

Figure 15-Longitudinal Slope Examples: Concrete Within Recommended Slope / Asphalt Outside Recommended Threshold)

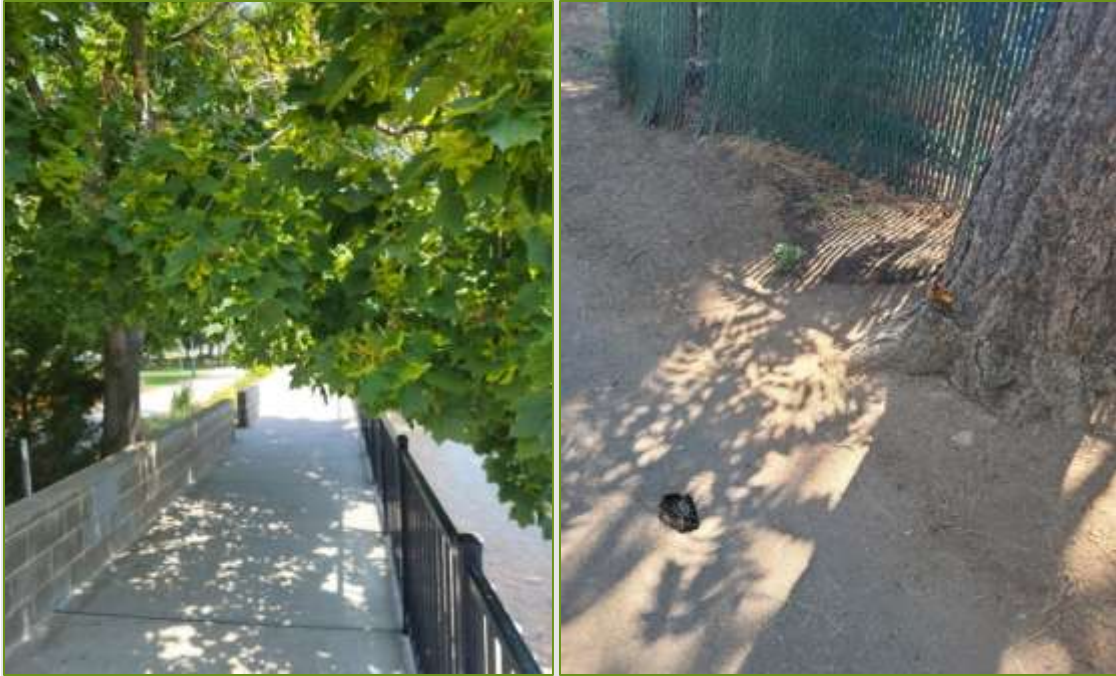
Obstructions were defined as vertical barriers within seven feet of path clearance and horizontal barriers within two feet of the path edge. A total of 67 obstructions were identified along the path, consisting of 54 horizontal obstructions and 13 vertical obstructions. Obstructions observed along the path included trees, foliage, and fencing, either along or through the path. Tree branches were the primary vertical obstructions. Both horizontal and vertical obstructions were found to be present throughout the path (Figure 29). Horizontal obstructions observed consisted of narrow fencing, poles, depressions in the path, and tree roots (Figure 30).

*Figure 30-Vertical Obstruction (Branch) and Horizontal Obstruction (Depression and Tree Root)*

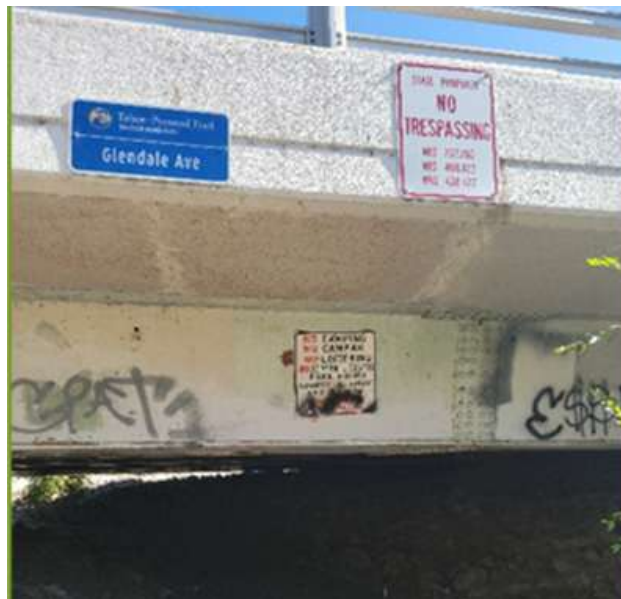
Two crossing types were observed at the eleven locations, at-grade crosswalks and grade-separated underpasses. The crosswalks had different styles of markings, which included standard and continental lines (Figure 32). The crosswalk on Sierra Street had signage on light poles to indicate to drivers the presence of a crosswalk. The underpasses varied in height, with high clearance on the underpass for I-580, and lower clearance on Glendale Avenue, which had a 7 feet -11 inches clearance (Figure 33). The path was found to cross over a roadway at 11 locations (Figure 34).

*Figure 33-Low Bridge Underpass*

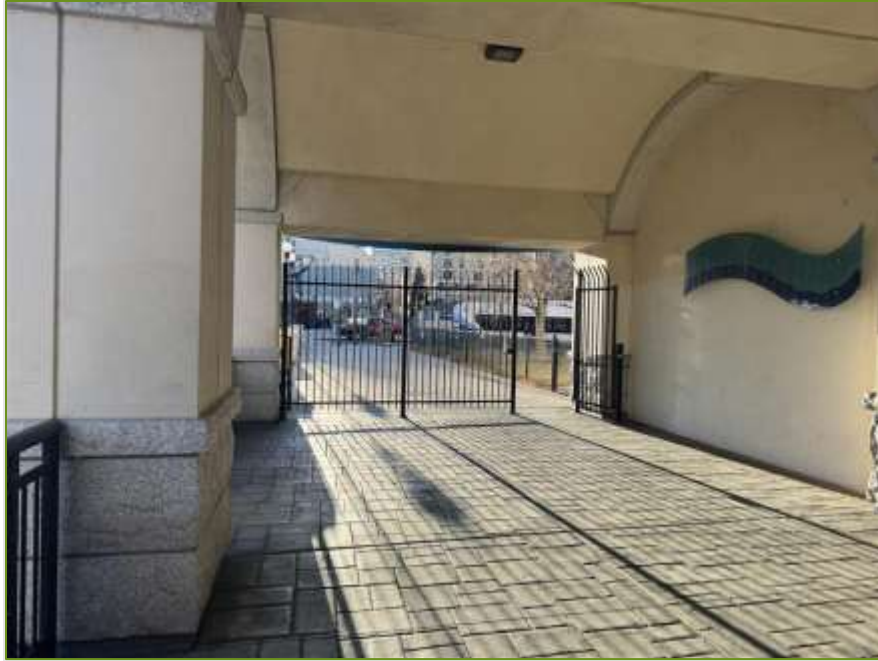
A potential point of path segmentation was observed along the path within the downtown Reno corridor. Specifically, the segment between South Center Street and Lake Street included two fences with lockable gates controlled by the private property owner (Figure 37). If these gates were closed, users would need to detour via East 1st Street, resulting in an additional travel distance of approximately 600 feet.

*Figure 37-Privately Owned Parcel with Gate (AT&T Communications of Nevada)*
