# TRUCKEE RIVER PATH INVENTORY STUDY REPORT

REGIONAL  
TRANSPORTATION  
COMMISSION

This report provides an inventory of the Truckee River Path, a 11.2 mile corridor of paved shared-use path, for non-motorized users, located along the Truckee River from Riverhaven Drive in Reno to Larkin Circle in Sparks. The inventory was conducted in July and August of 2024 and includes both the physical infrastructure of the path and observations of the surrounding environment that may impact user experience.

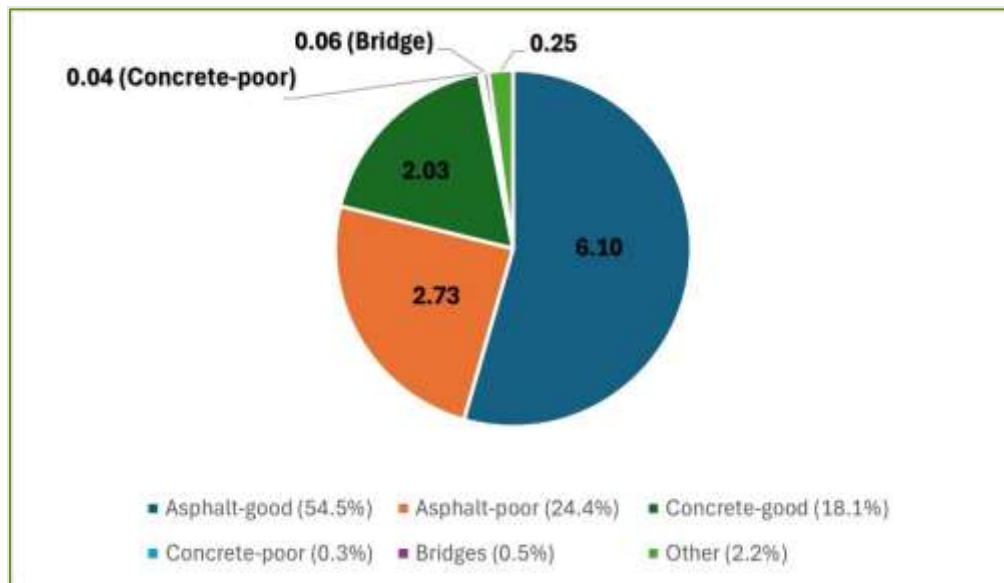
Figure 5-Surface Material and Condition

The remaining 0.06 miles (0.5%) consist of bridges, which are constructed with a variety of wood products. All wooden bridge surfaces were found to be in good condition. About 0.25 miles (2.2%) of the path was not assessed due to accessibility or safety reasons. These segments are classified as “Other”. Path locations with the most concentrated areas of poor surface condition were between Lake Street and Galletti Way, where sections of asphalt displayed wear, including horizontal and vertical cracking, crumbling edges, and uneven surfaces (Figure 6).

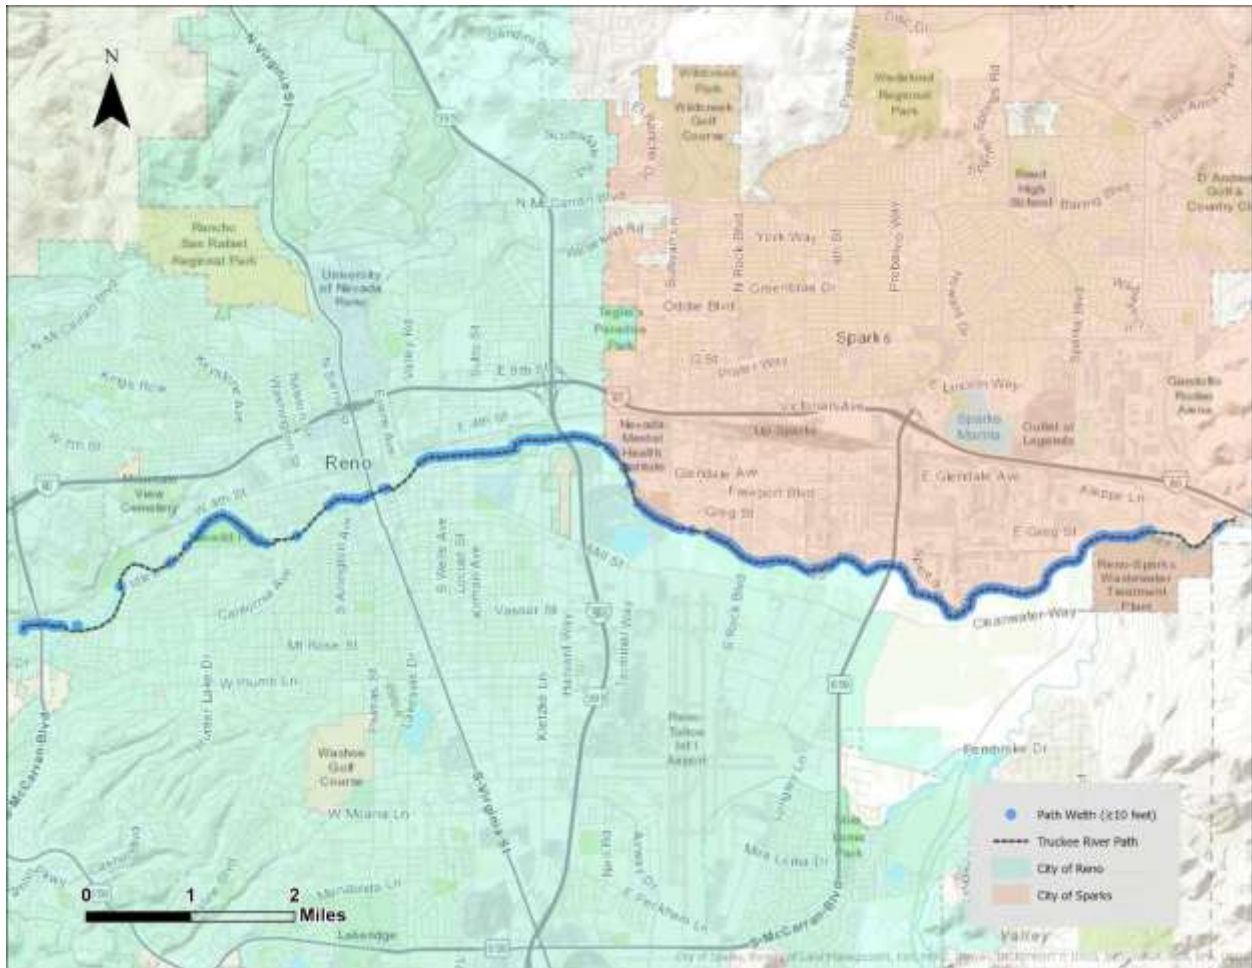
Figure 7- Path Width Meeting FHWA Recommendation (10 feet)

The path was found to have an average width of 10.85 feet, with 61% of the path meeting the FHWA recommended minimum width of 10 feet for two-directional shared-use paths. Figure 7 shows locations of the path where the width meets the 10-foot recommendation. The mileage and percentage of the path meeting or not meeting the FHWA recommended width are shown in Figure 8.

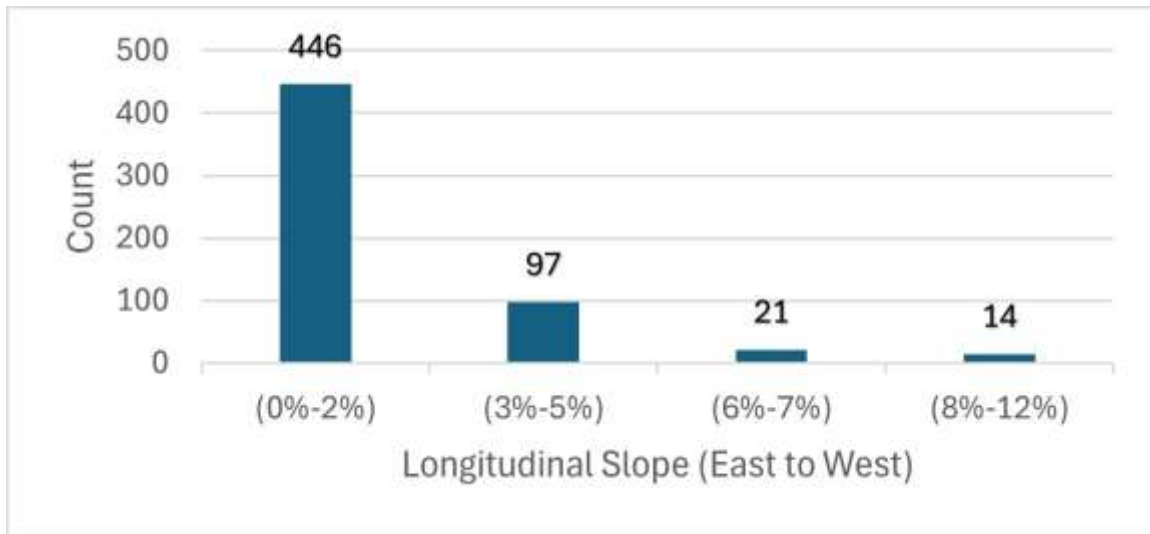
Figure 11- Longitudinal Slope

The path was found to have an average longitudinal slope (east to west) of 1.97% (Figure 11), with 92% of the path within the FHWA recommended 5% slope (Figure 12). However, throughout the path, there were several outlier slope measurement locations, including short inclines and hill-like rises. These variations in slope were primarily due to the natural topography of the area, as well as adjustments made to navigate bridges, overpasses, and other infrastructural elements.

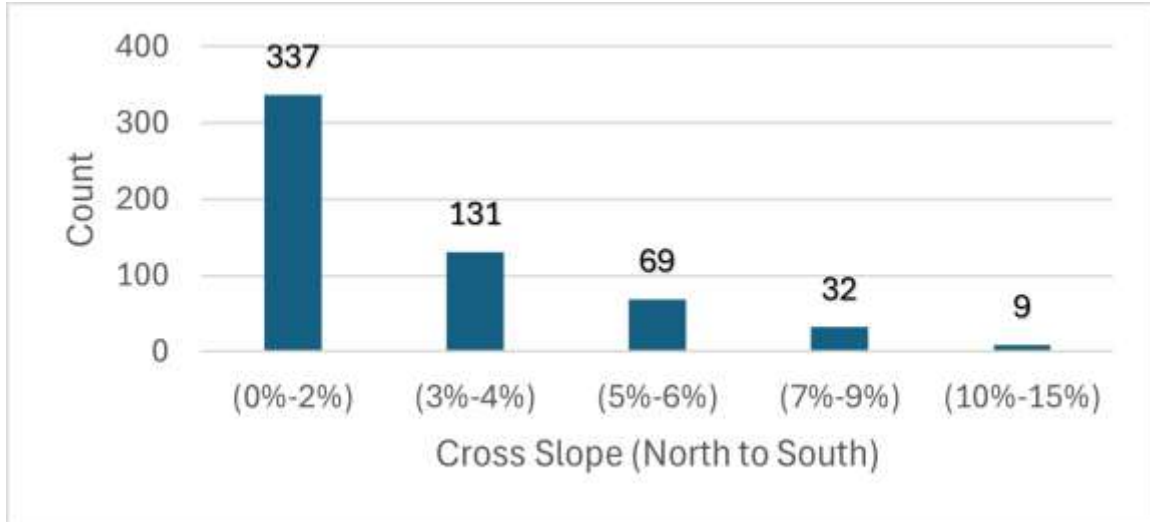
Figure 13-Cross Slope

The path was found to have an average cross slope (north to south) of 2.73% (Figure 13), with slope varying between 0% and 15%, with about 57% of the path meeting the 2% cross slope recommended maximum (Figure 14). The outlier areas with higher grade slopes were primarily associated with specific features such as sidewalks and driveway access in residential areas, particularly along Idlewild Drive in Reno. These sections typically had steeper inclines due to the presence of driveways and residential access points. In addition to these outliers, higher-grade slopes were also observed in multiple concrete sections along Riverside Drive and asphalt areas throughout the path.

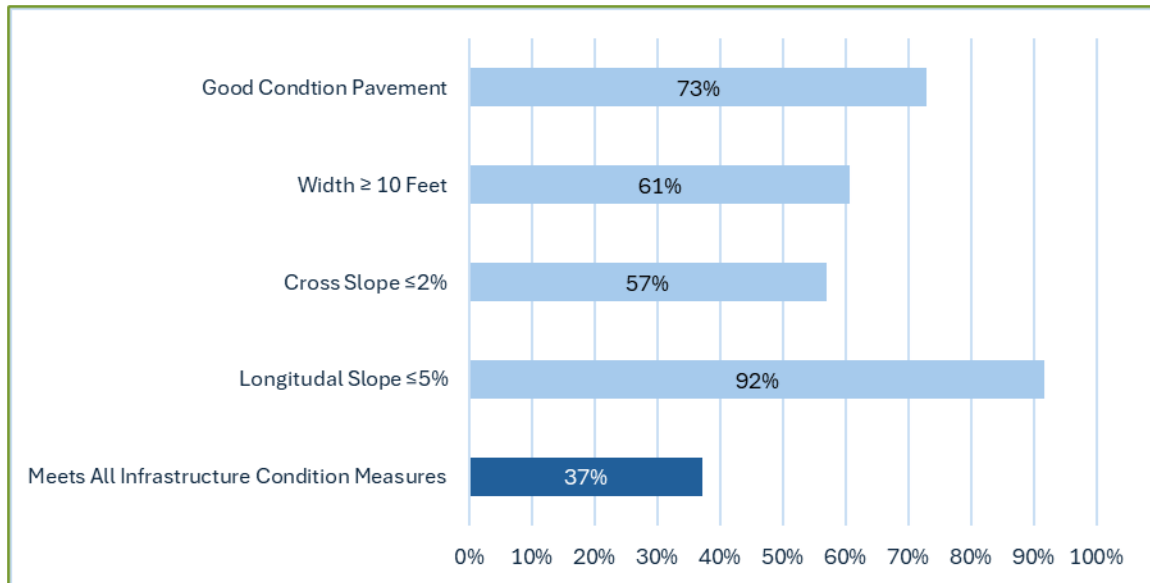
Figure 17-Percent of Path Meeting all Measures

37% of the path was found to meet all three FHWA recommendations (width, cross slope, and longitudinal slope) and was also found to have good pavement surface condition (Figure 17).

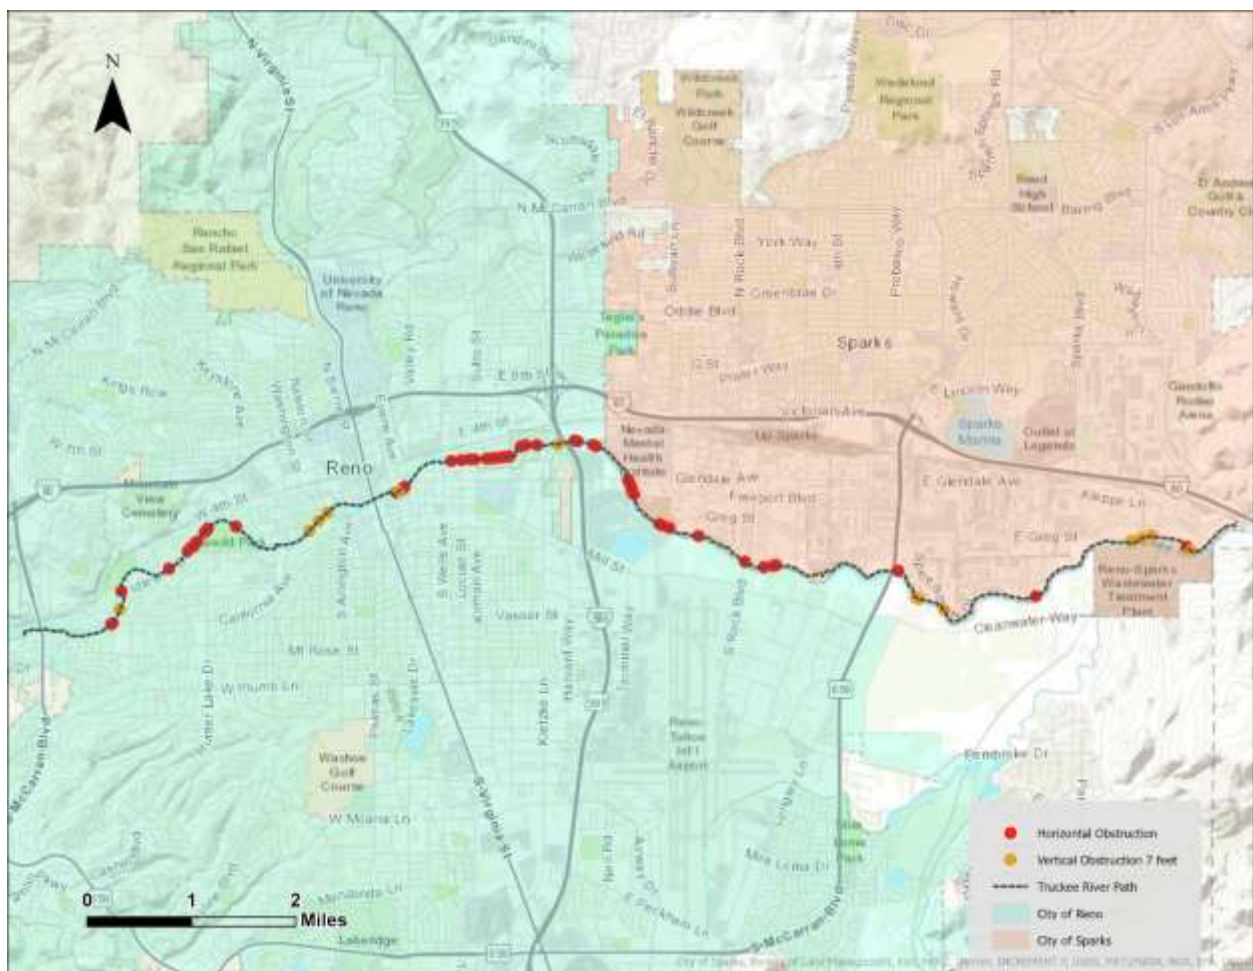
Figure 29-Vertical and Horizontal Obstruction Locations

Obstructions were defined as vertical barriers within seven feet of path clearance and horizontal barriers within two feet of the path edge. A total of 67 obstructions were identified along the path, consisting of 54 horizontal obstructions and 13 vertical obstructions. Obstructions observed along the path included trees, foliage, and fencing, either along or through the path. Tree branches were the primary vertical obstructions. Both horizontal and vertical obstructions were found to be present throughout the path (Figure 29). Horizontal obstructions observed consisted of narrow fencing, poles, depressions in the path, and tree roots (Figure 30).

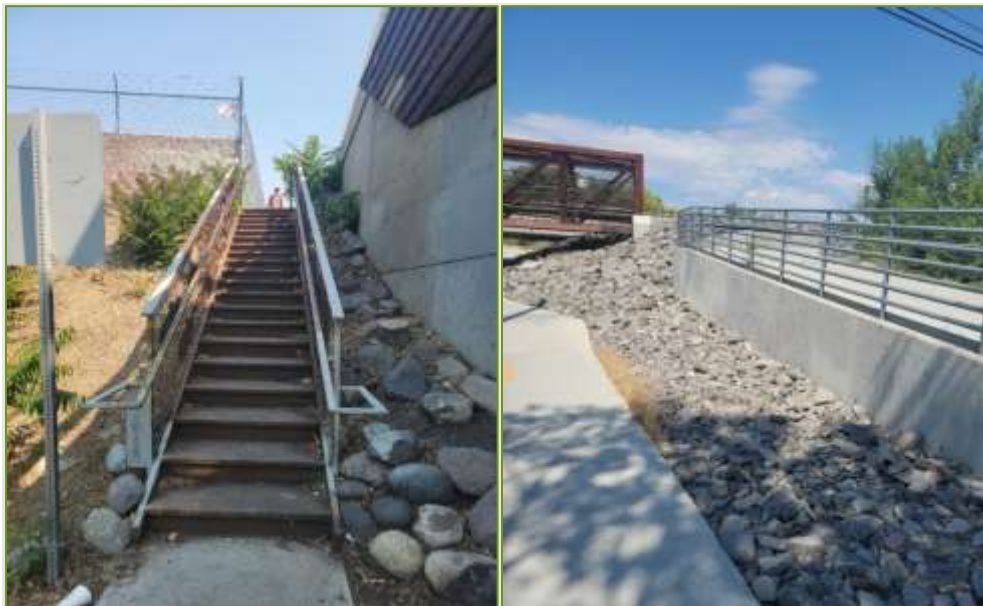
Figure 36-Access Point Types

A total of 44 access points were observed along the path, with a high concentration located in the Riverwalk District of Reno (Figure 35). The access points included pedestrian walkways, curb ramps, paths, inclined ramps, stairways, and river access ramps (Figure 36). Several of these access points were connected to parking lots. The access points were distributed throughout the corridor and varied in surface material and condition.
